COMMENTS ON THE TMC REPORT

“RENA – FULL WRECK REMOVAL FEASIBILITY APPRAISAL”

Date: 18 August 2014

Our Ref: 5750/LOCS/NEH/R008

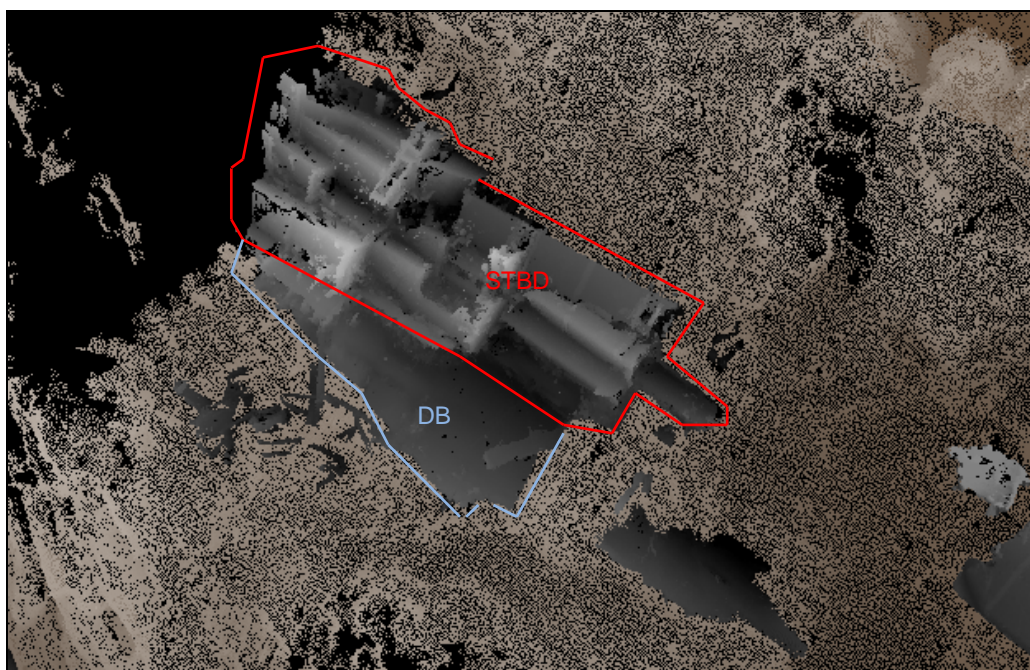
Figure 1. ADUS April 2014 Screenshot of Bow Area.

The extract shown below at **Figure 1** shows the starboard side of the bow section (coloured **RED**) and double bottom of the bow section (coloured **BLUE**). The black area in the top left hand corner of the ADUS screenshot shows an area not surveyed due to shallow water, it can be seen from the screenshot that the upper edge of the starboard side is within the black area (not surveyed), this is the area referenced in the Gorman & Mitchell report and discussed at paragraph 3.5.4 above.

We know from other figures provided in the TMC report⁸ that the forward end of the bow section is contained within a 2 metre contour. From the evidence provided, scanty though it is, I am of the opinion that at least part of the starboard side of the bow section is shallower than the claimed -1 metre LAT.

I will reiterate what is stated in paragraph 3.5.1 of this report, there is no evidence provided that shows that the -1 metre LAT was ever achieved and furthermore there is no evidence provided that shows that this level has been maintained. In fact the evidence provided in the Beca provided Gorman & Mitchell report and the two MNZ weekly SITREPs would appear to show the opposite and that movement has caused the bow section move into shallower water. Owner and TSC must provide documented evidence that the -1 m LAT was achieved and is being maintained.

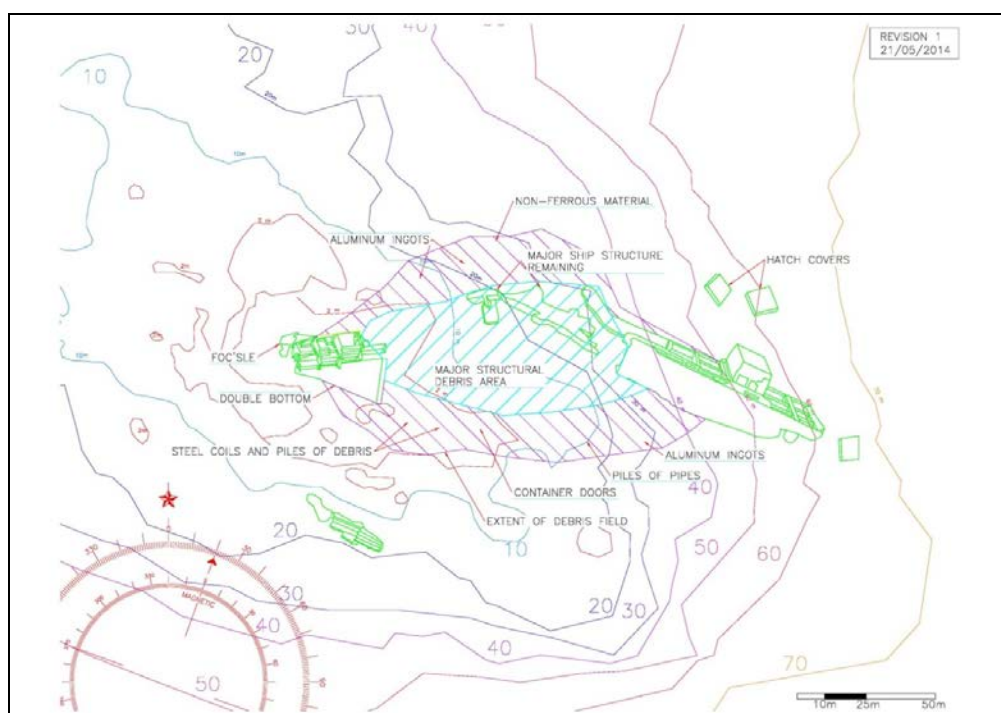
Figure 2: Debris Field, May 2014

The extent of the principal debris field is shown in the figure below at **Figure 2** which is extracted from the TMC report¹⁰

The TMC report advises that following the latest underwater surveys, clean-up operations to remove the debris field have commenced. Resources include divers, an electromagnet and an orange peel grab. At the time the TMC report was produced (end of April 2014), 467 tonnes of metallic cargo, 298 tonnes of ship debris and 119 tonnes of non-metallic debris had been recovered. This totals 884 tonnes of mixed debris. TMC estimate there is approximately 4125 tonnes of debris remaining within the debris field. The report advises that in general the debris is considered relatively benign,

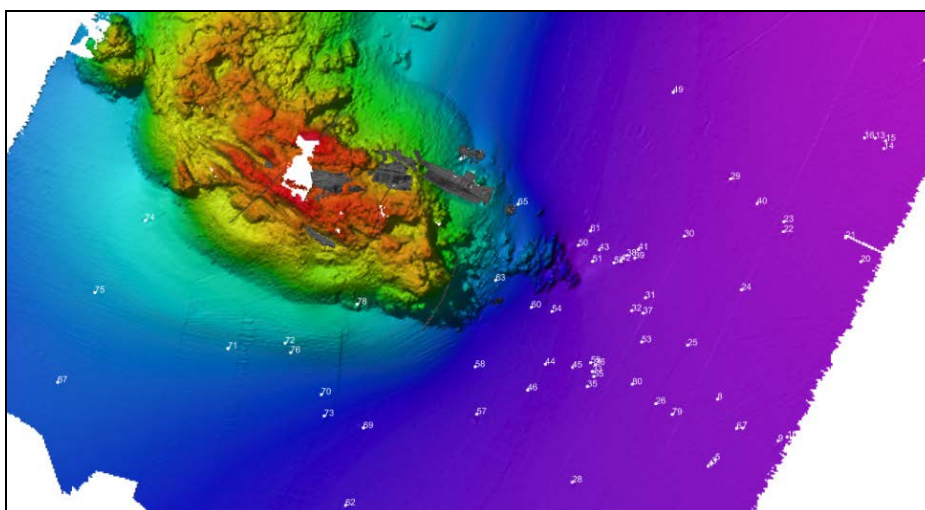
Figure 3: ADUS Side-Scan Sonar Targets (suspected debris field).

3.5.12 The TMC report also advises that the side-scan survey undertaken in April 2014 of the level seabed surrounding the Astrolabe Reef revealed a number of possible debris targets. Whilst the various locations have been documented, at the time the TMC report was written no targets have been positively identified as debris. The extract below¹¹ shows the various targets identified within the ADUs survey as "suspected" debris targets:

Whilst it may be the case that none of the targets shown above have been "confirmed" as debris targets, it can similarly be stated that none have discounted, as such it is highly likely that at least a percentage of these targets do consist of debris. It is well known that items of debris continue to

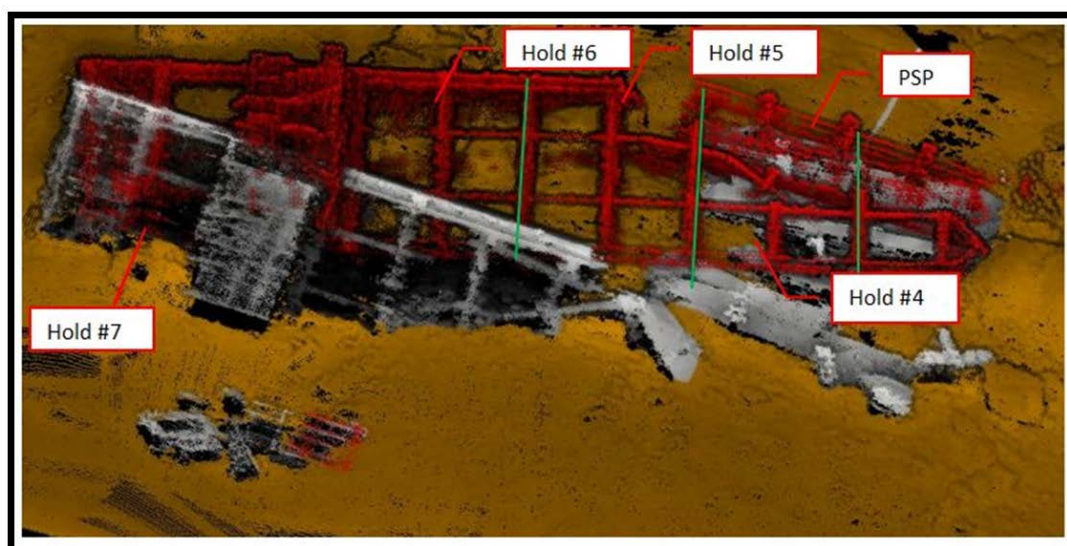
Figure 3: ADUS Survey in 2012 (Red) and April 2014 (Grey).

- 3.5.13 Chapter 4.4 of the TMC report deals with the Aft Section of the wreck. The aft section is fully submerged and laying on its starboard side at 63° with an aft trim of 4°, at its deepest the aft end is at 56 metres water depth. The total estimated weight of the aft section is approximately 10,353 tonnes (prior to any removal), however reference should be made to the table extracted from the TMC report and provided as **Figure 4** of this report which shows that the estimated weight remaining of the aft section is 7727 tonnes.
- 3.5.14 The April 2014 survey shows that Holds number 4 and 5 have collapsed completely. The significant changes to the section are clearly illustrated in the illustration below which shows the position of the section in 2012 (shown in Red) and 2014 (shown in Grey).

The survey would appear to show that all longitudinals forward of the accommodation have been compromised and that Hold 7 appears to also be crushing.

- 3.5.15 Also evident from the survey is the fact that the containers within the cargo holds have all been damaged/crushed and they form part of the general debris contained within the holds.

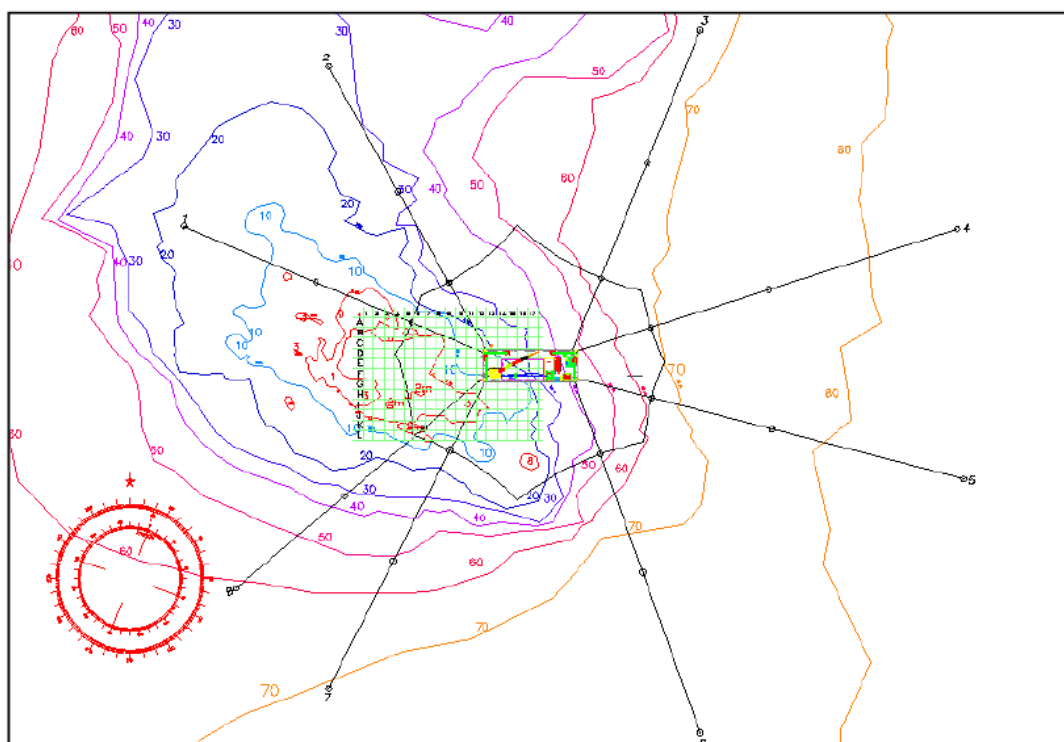
Figure 6: Debris Removal Barge Mooring Arrangement.

The drawing at **Figure 6** below shows the planned mooring spread. The barge will use soft lines which will be connected to the anchor/chains. This will allow the spread to be moved around the debris field using the mooring winches fitted to the barge. Despite TMC's concerns at damaging the reef using anchors, this is the method being utilised.

The removal operation will be undertaken systematically. The debris field has been sub-divided into a datum grid. The grid system is used in conjunction with a Hypack (navigation) software package already installed on the barge. Each of the grids forms a 10m x 10m box. The navigation software will be used to position the LARS (Diver launch and recovery system) exactly within the grid reference.
