### REPORT ON THE COMPARISONS BETWEEN RENA AND OTHER WRECK REMOVAL OPERATIONS IN RECENT YEARS

Date: 09 July 2014

Our Ref: 5750/LOCS/NEH/R007

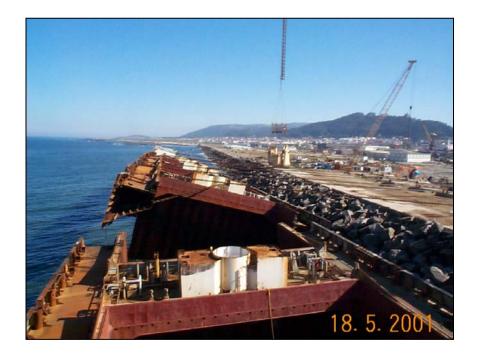
Figure 2: Parbuckle of forward section.

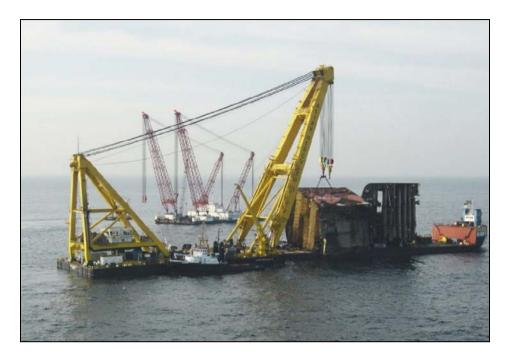
Figure 3: Successful lift of second wreck section.

The TRICOLOR collided with the KARIBA on 14 December 2002 in the vicinity of the Hinder No 1 buoy in the French EEZ of the English Channel. The TRICOLOR sank in 27 metres of water and came to rest on the sea bed, overturned sideways with the starboard side facing up. The TRICOLOR had sunk in a very busy part of the traffic separation scheme and represented a hazard to navigation given its exposed position. The TRICOLOR was carrying 2,871 cars.

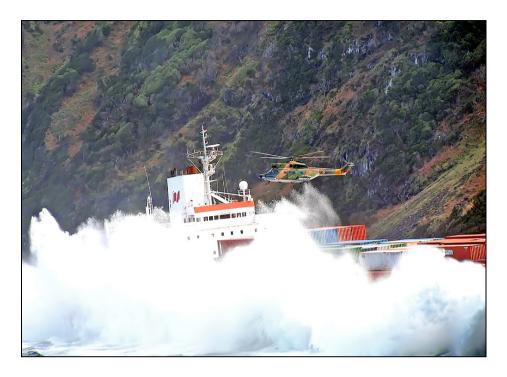
Figure 4: Removal of DG Cargo by Helicopter.

All hazardous cargo was required to be removed from the ship. The contractors responded to this stipulation by chartering a helicopter which was dismantled in central Africa, transported to the site (in the Azores) and then returned to central Africa. However, the helicopter only succeeded in removing two 40' containers and the contents of one 40' container.

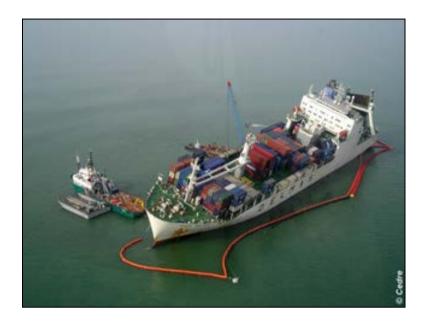
Figure 5: Removal of hydrocarbons.

There was a high level of intervention on the part of the French government and local authorities which resulted in significant additional cost. The French authorities required pollutants and deck cargo to be removed before SCOPIC could be terminated. The local authorities required asbestos to be removed and disposed of in accordance with French regulations at a cost of  $\in$ 12.2 million. The site was returned to its pre-grounding condition and the wreck and cargo were removed in their entirety.

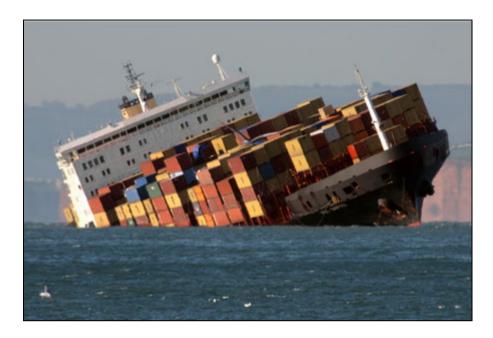
Figure 6: MSC NAPOLI beached in Lyme Bay.

The vessel lay aground and semi-submerged vulnerable to the effects of the sea. On 20 January, she developed a 40° list leading to the loss of over 100 containers during deteriorating weather conditions. Some of the lost containers sank but many washed up on the beach. The local police did not secure the relevant beaches for several days and as a consequence there was substantial looting from the accessible containers. The removal of the containers from the shore/seabed was not completed until the end of September 2008.

challenges (pronounced list, distortion of containers and cell guides and storage capacity ashore) and by the time it was viable to attempt a refloating and tow, it was determined that the hull had suffered too much damage for this to be a realistic option. At this point the method moved to one of removing the ship in parts. The forward section was separated, refloated and towed to a shipyard in Belfast for scrapping. This phase was completed in March 2008. The weight of the engine necessitated a different approach being adopted for the aft section. The initial plan involved dismantling this section on site. However, the cutting equipment deployed by the salvors - used successfully on the ROKIA DELMAS casualty - proved unable to deal with the larger steel sections of this vessel. Accordingly, in close consultation with the SCR, a new plan was developed. This entailed passing a number of hoisting wires under the hull and attaching them to winches fixed to two large barges. The aft section was successfully lifted from the seabed in July 2009.

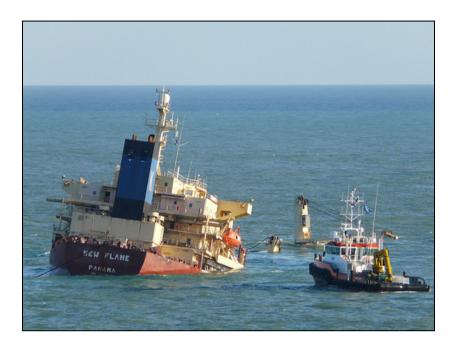
Figure 7: NEW FLAME prior to wreck removal operation.

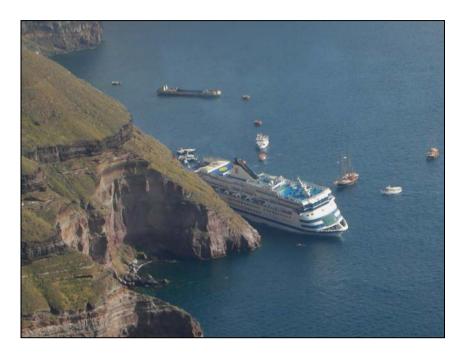
Figure 8: SEA DIAMOND prior to beaching/capsizing.

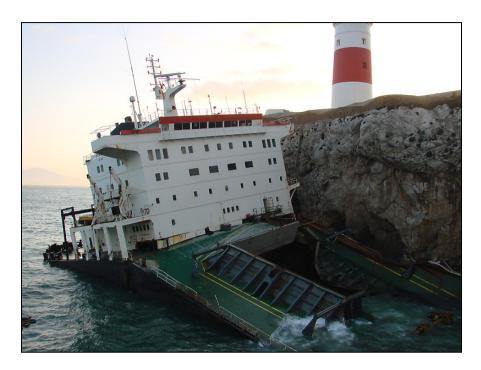
Figure 9: FEDRA at the foot of Europa Point.

The FEDRA, a gearless bulk carrier, dragged her anchor in deteriorating weather conditions and despite the attendance of tugs, grounded at the foot of Europa Point on 10 October 2008. The vessel grounded in an upright position.

The vessel grounded at Europa Point in a very exposed position with adverse weather conditions and strong tides. Difficult access from the sea and steep cliffs ashore, weather and sea state conditions and the proximity of a major sewer overfall resulted in the operations being extended by some 50 days. Some of the required response equipment was available locally and took less than one week to mobilise. The contractors Titan were already available on site dealing with a previous casualty and dealt with bunker removal and refloating of the bow section and removal of the accommodation block. The removal of the stern section went to tender. Donjon Marine was awarded the

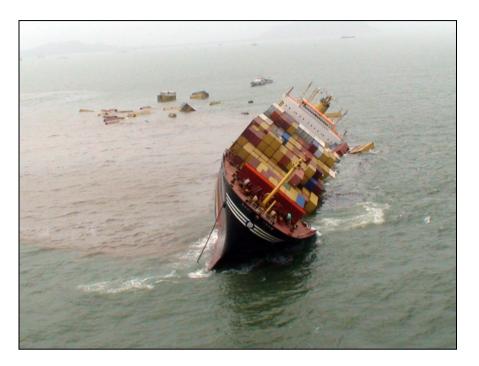
Figure 10: MSC CHITRA Prior to wreck removal.

The MSC CHITRA, a container vessel, collided with the "Khalijia 3" whilst leaving the port of Mumbai on 7 August 2010. Following the collision, MSC CHITRA proceeded a short distance before grounding on a shallow clay seabed and lay aground with a list, semi submerged and was considered a navigational hazard.

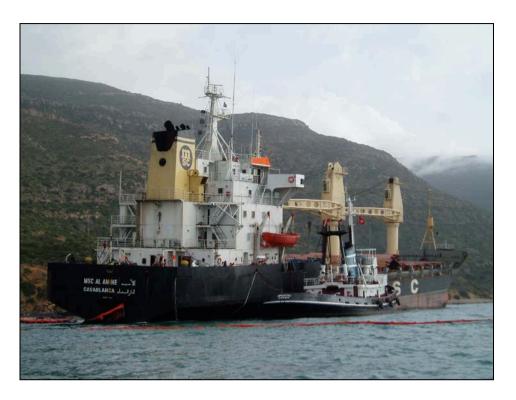
Figure 11: MSC AL AMINE Aground at Qurbus.

On 15 February 2005, the Moroccan-owned, 13-year-old, 137 m long container ship MSC AI Amine suffered mechanical failure, dragged anchor and grounded in the Gulf of Tunis near the Qurbus in the Gulf of Tunis, spilling 100 to 150 tonnes of heavy fuel oil.

The vessel was carrying very few containers within the holds as she was anchored and awaiting cargo in the Gulf of Tunis. The initial grounding caused the engine room to flood and caused damage to the double bottom fuel oil tanks which resulted in the oil entering the cargo holds through cracks in the tank top. Oil was removed from the damaged tanks prior to the refloating operation.
