COMMENTS ON THE TMC REPORT

“RENA – FULL WRECK REMOVAL FEASIBILITY APPRAISAL”

Date: 18 August 2014

Our Ref: 5750/LOCS/NEH/R008

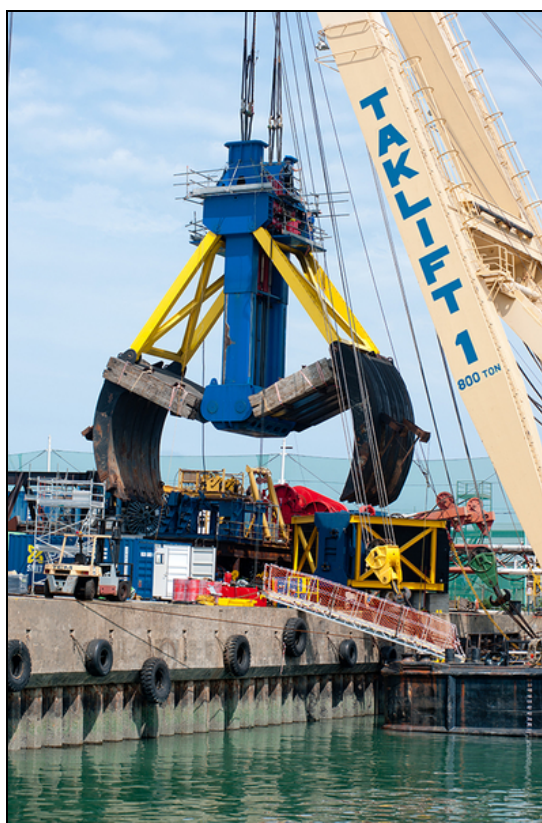
Figure 5: SMIT Wreck Grab HDW1

3.6.9 I also note that no consideration has been given to using the large SMIT wreck grab¹³. This grab is ideally suited to this work and has been used very successfully on numerous wreck operations. See **Figure 5** below which shows the wreck grab.
